LANDSLIDES AND RELATED FEATURES

OF THE MUNDERF, PA. QUADRANGLE

by
John S. Pomeroy
1981

U.S. Geological Survey
OPEN FILE MAP 81-238 C-9

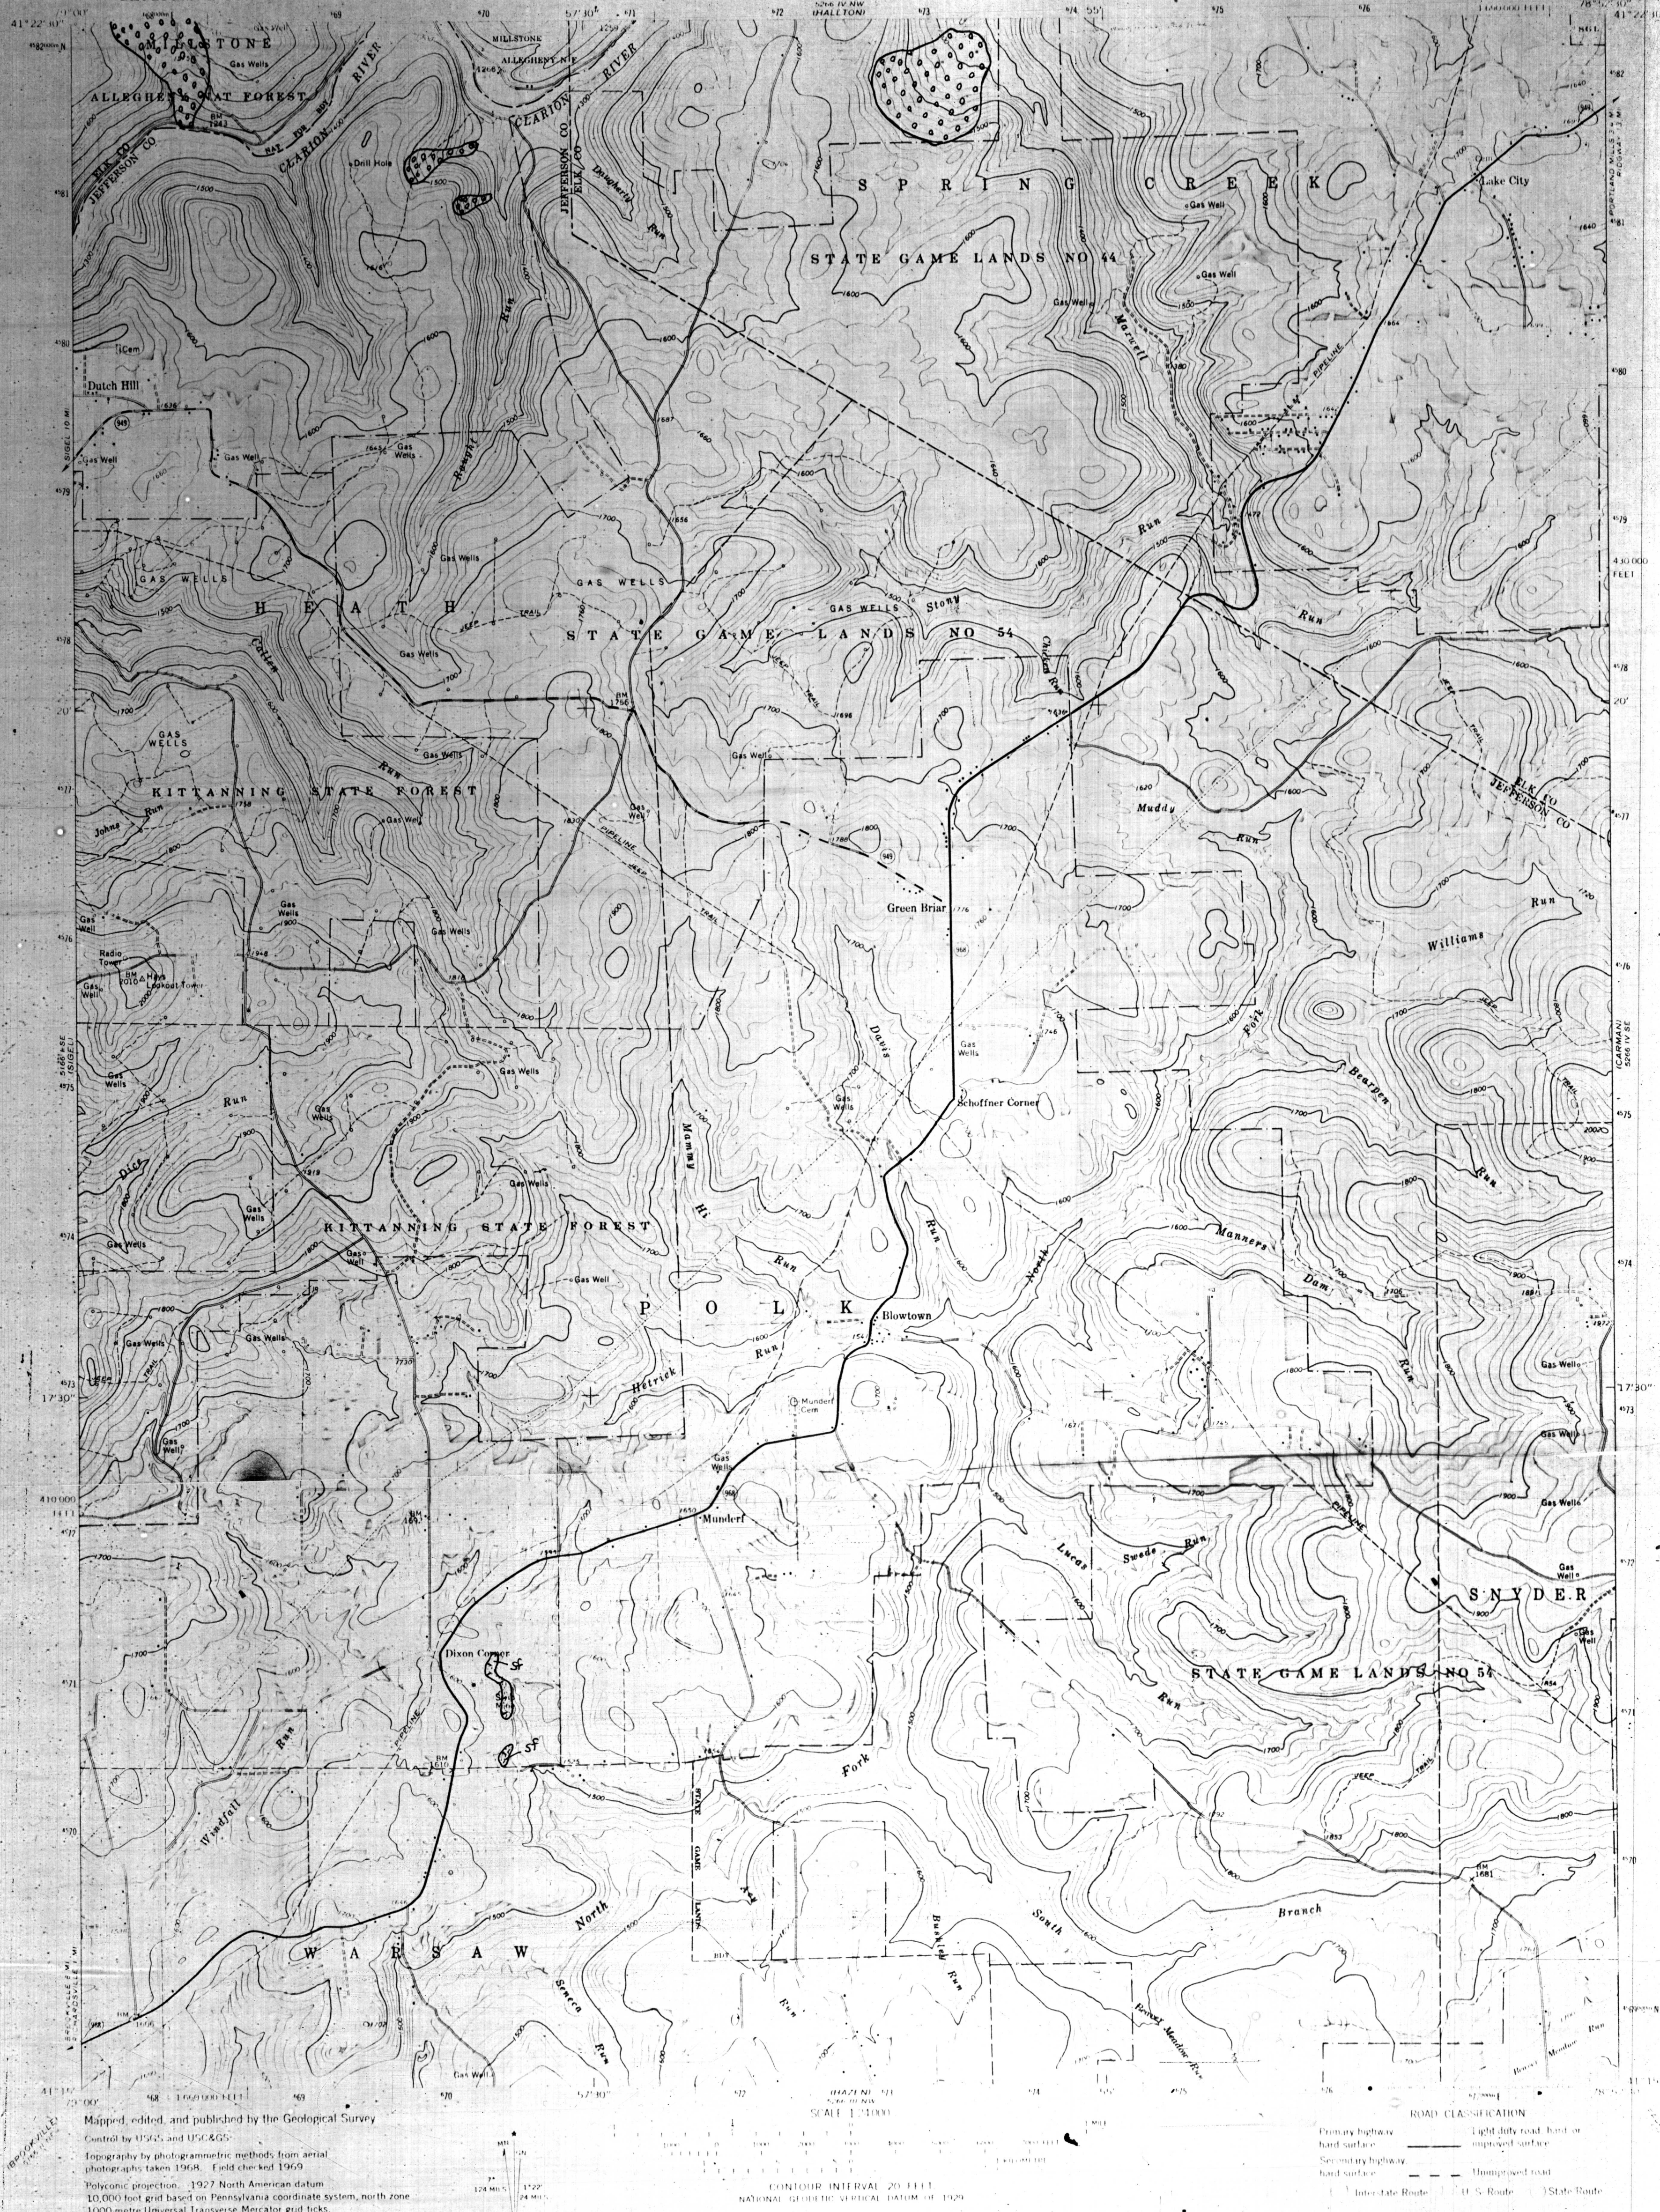
Landslides and related features interpreted
from aerial-photographs
1:78,000 (black and white) 1977.

Photointerpretation and field check 1978-1979
This map has not been edited or reviewed
for conformity with Geological Survey
standards and nomenclature.
